Comparison of Squats and Studs from different traffic environments

Shaun Earl, Prof. Roger Lewis, Prof. Mark Rainforth: University of Sheffield

1. Squats and STUDs
2. The use of μ -CT scanning on rail defects
3. X-ray Micro-Computed Tomography (μ -CT) Scanning
4. Scan verification
5. Sample 1
6. Sample 2
7. Sample 3
8. Sample 4
9. Concluding remarks

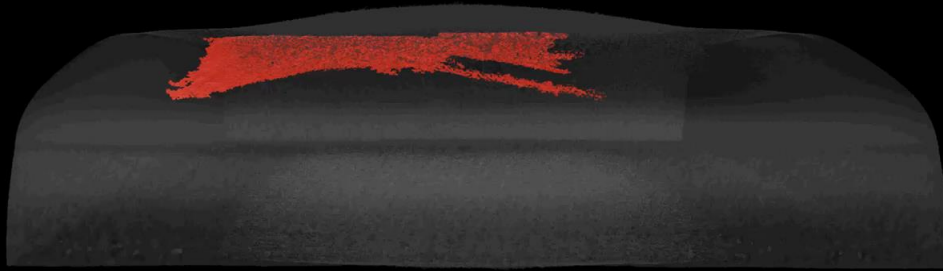
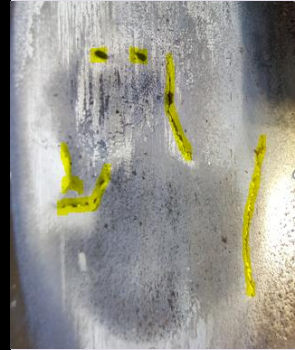
Sample 1

- From an incline just outside a station
- Multiple surface breaking cracks
- Typical crack structure that branches
- Initiated on the field corner

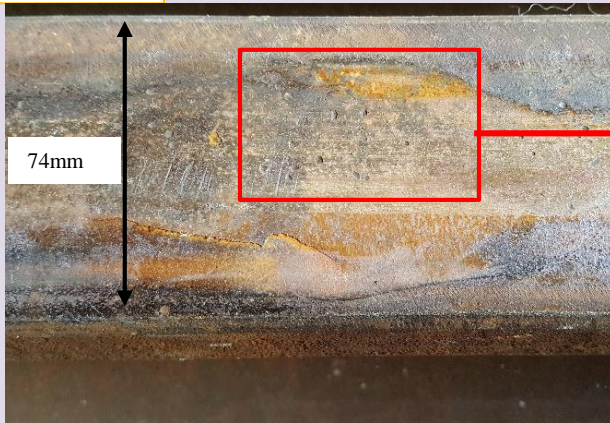
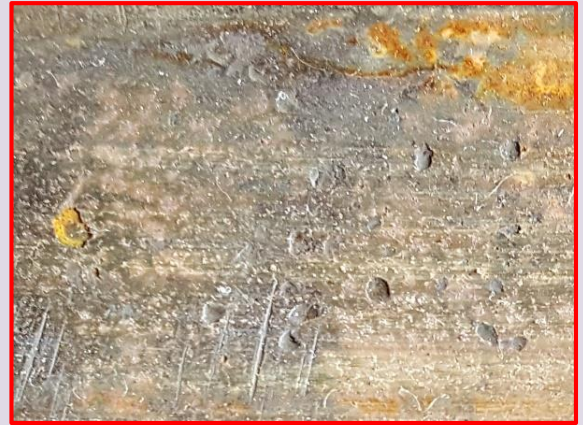
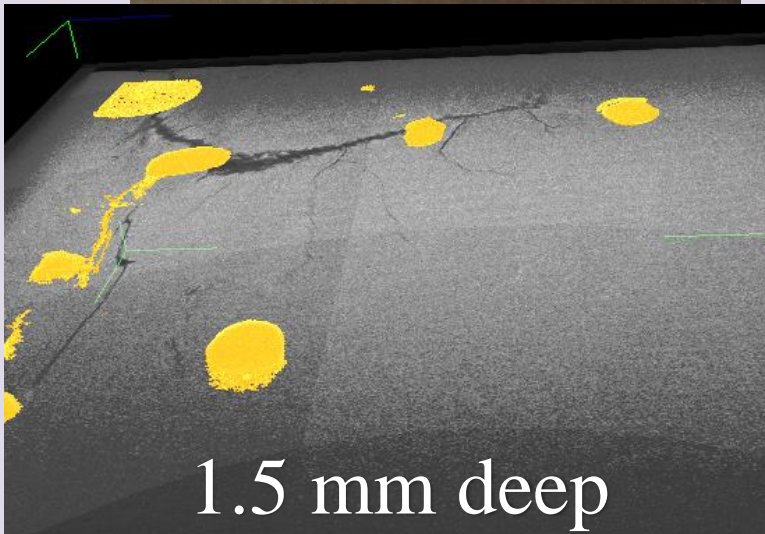
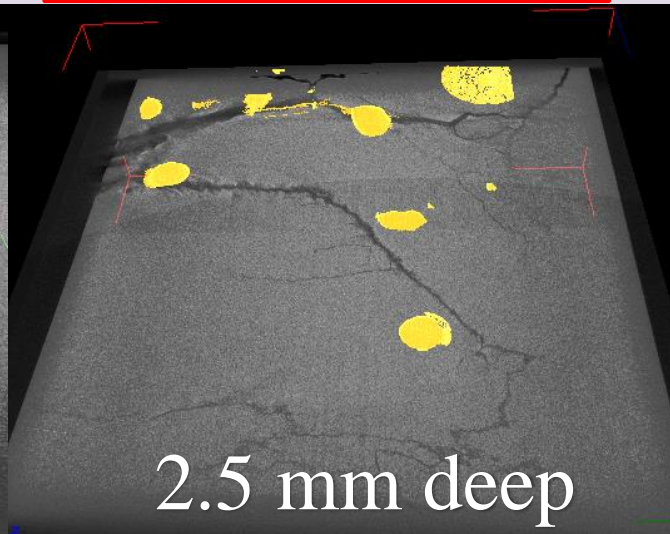
Sample 2

Crack paths compared to pit locations

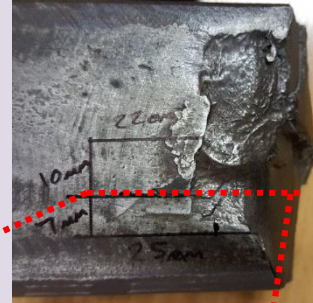
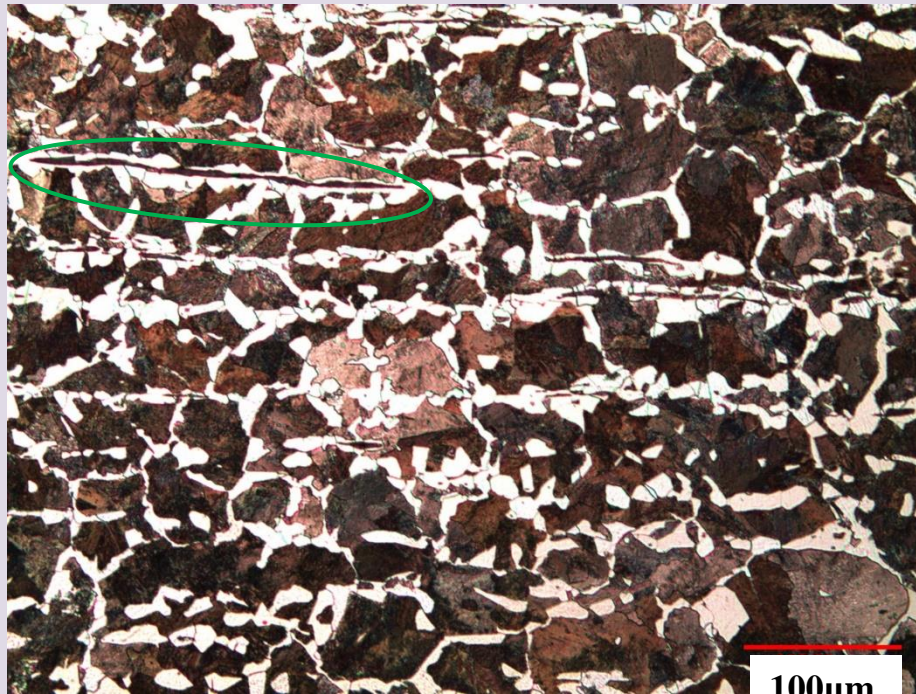
Sample 3

Inclusions found throughout sample and in multiple regions.
Inclusions run parallel to subsurface crack

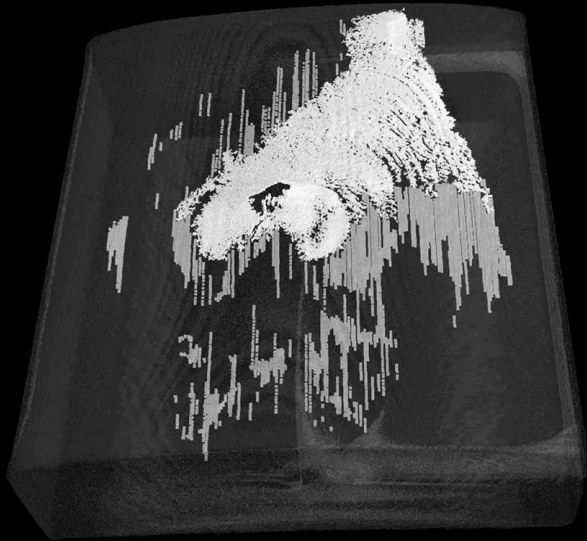
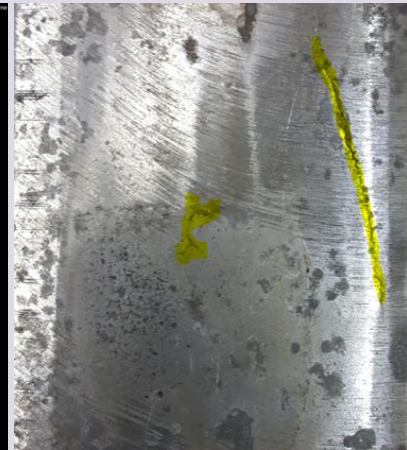
Sample 4

Automatic functions could not detect a large portion of the crack plane. Manual additions were made.
