# Evaluation of metallurgical risk factors in post-test, advanced 9%Cr creep strength enhanced ferritic (CSEF) steel

Yuki Zhang

# Microstructure Overview of A Novel 9Cr Steel

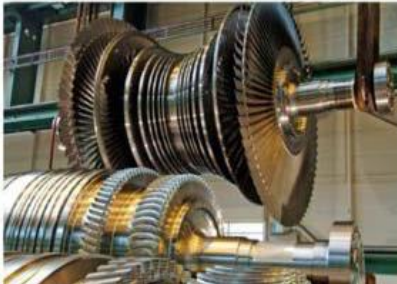
Applications of 9–12 wt. % Cr steels in fossil fuel power stations

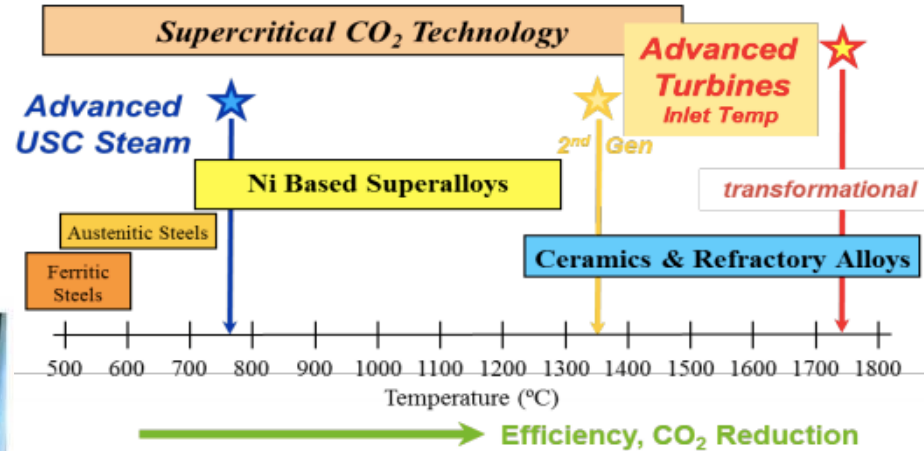
Evolution of power plant component steels as a function of temperature

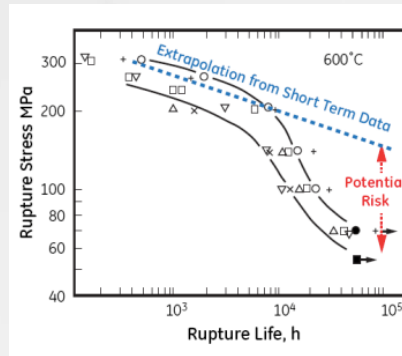
Z-phase, Laves phase, MX and/or  $M_{23}C_6$ , can cause an unexpected decrease in rupture stress as a function of time.

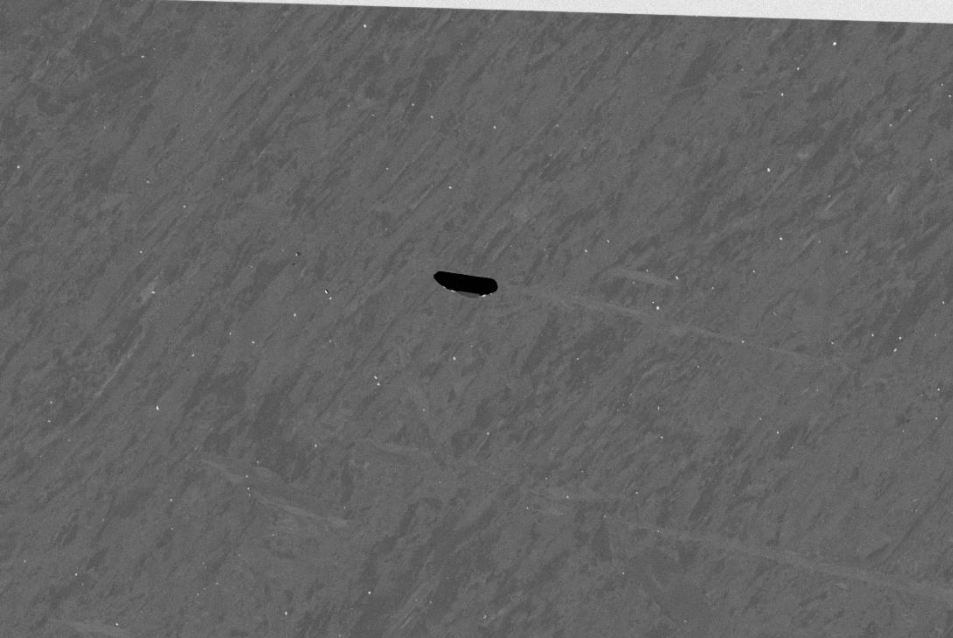
*BSE micrograph of the as-receive CPJ7 steel sample*

- **Strong channelling contrast in the martensite matrix**
- **Machine learning models must be applied**

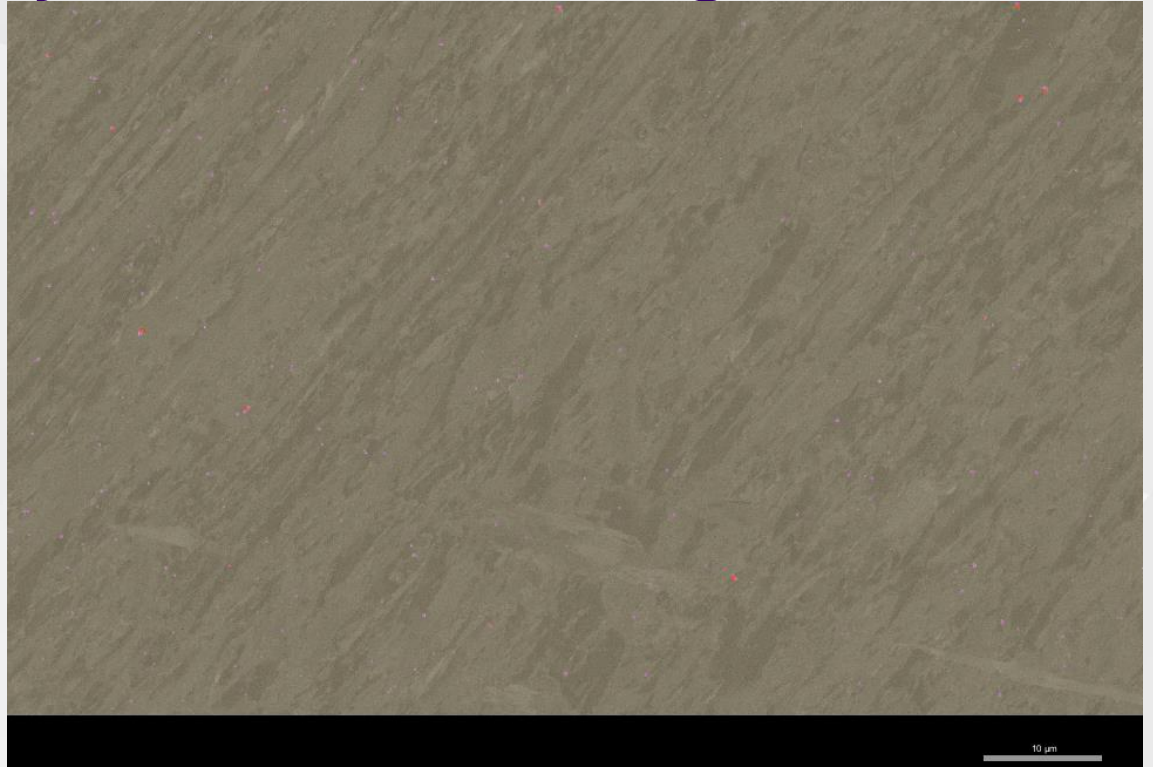
Phase segmentation results from machine learning

Pink = TaC

Green = cast pores

Red = MnS

*BSE slices of the as-manufactured CPJ7 steel sample after phase segmentation by machine learning*
