# Optimisation Of Next Generation Galvanising Pot Hardware

Presenter: Giovanni Paolo Alparone<sup>1</sup>

<sup>1</sup>Swansea University

<sup>2</sup>Tata Steel

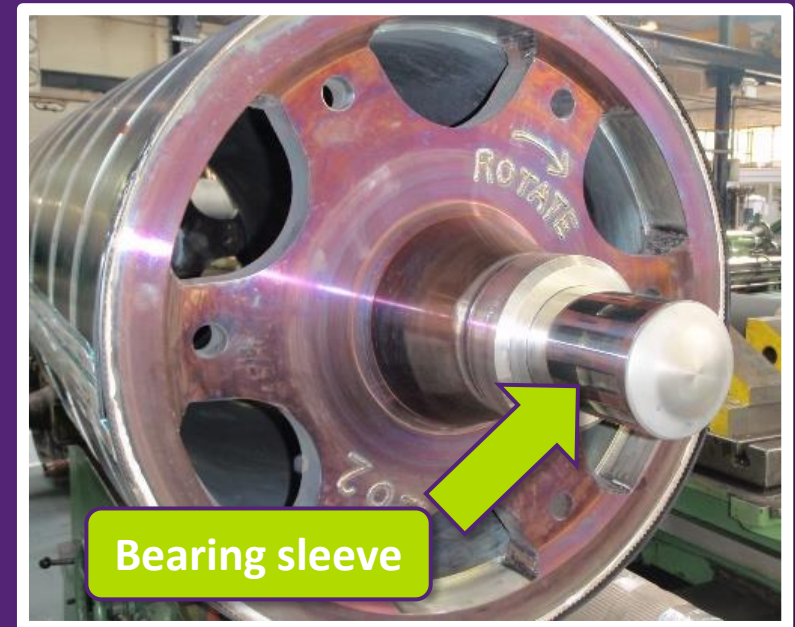
- **Zn attack:** bearing materials react with molten zinc, forming complex reaction products
- **Limited service life:** the reaction products affect the durability of the bearings, leading to deterioration of the bearing surface
- **Improving durability:** Implementing bearings with extended lifetime reduces downtime for maintenance
- **Impact on production and quality:** higher production yields and improved quality

*Galvanising pot hardware*

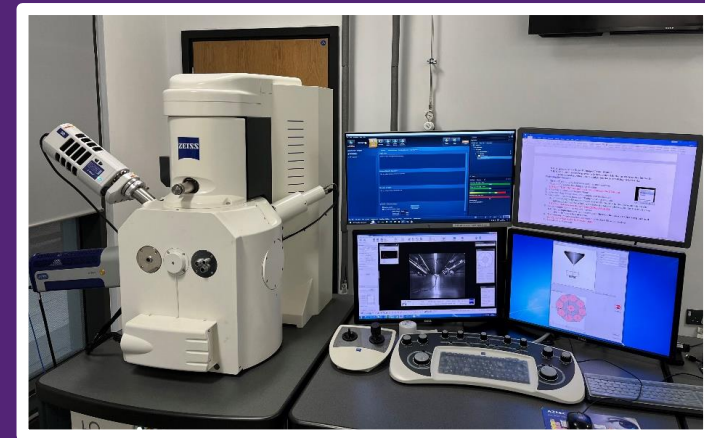
ZEISS EVO SEM with EDS detector

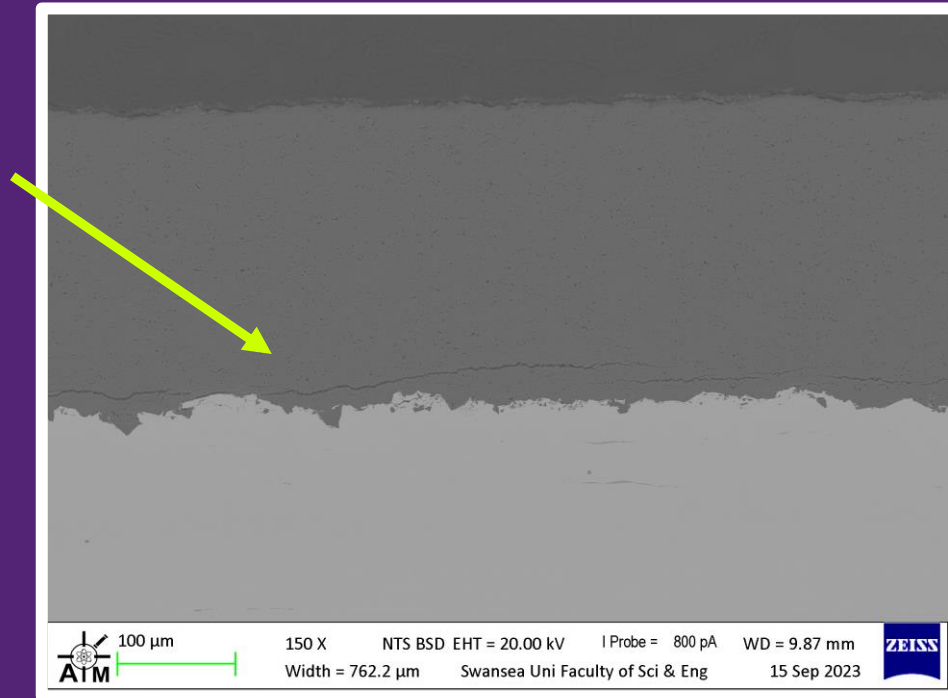
# 1 Week of Testing

horizontal cracks

coating missing

horizontal crack

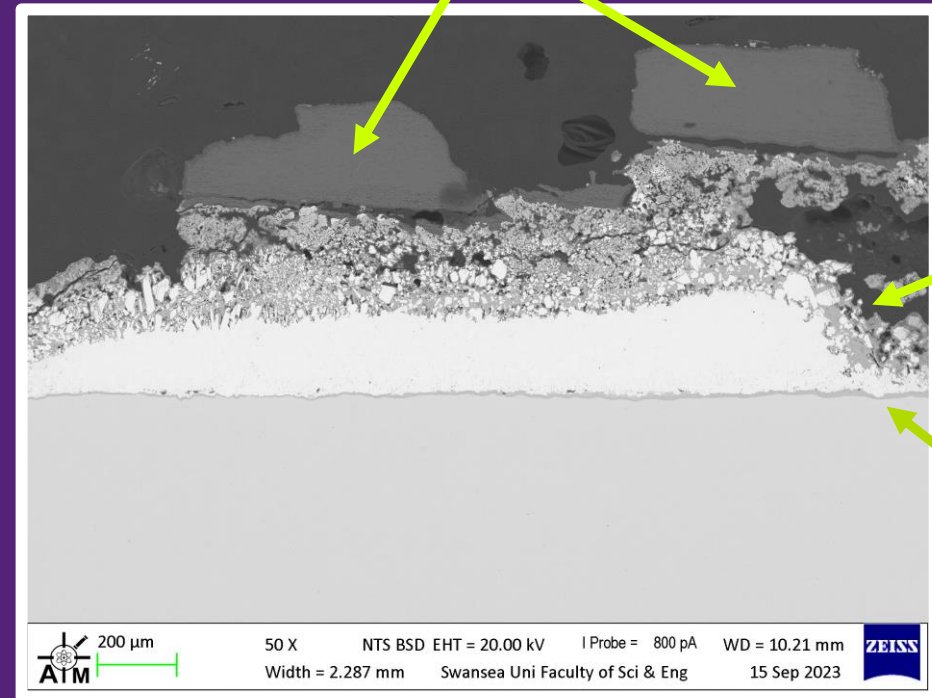
# 3 Weeks of Testing

vertical crack

large horizontal crack

fragments of coating

residual Zn

diffusion layer

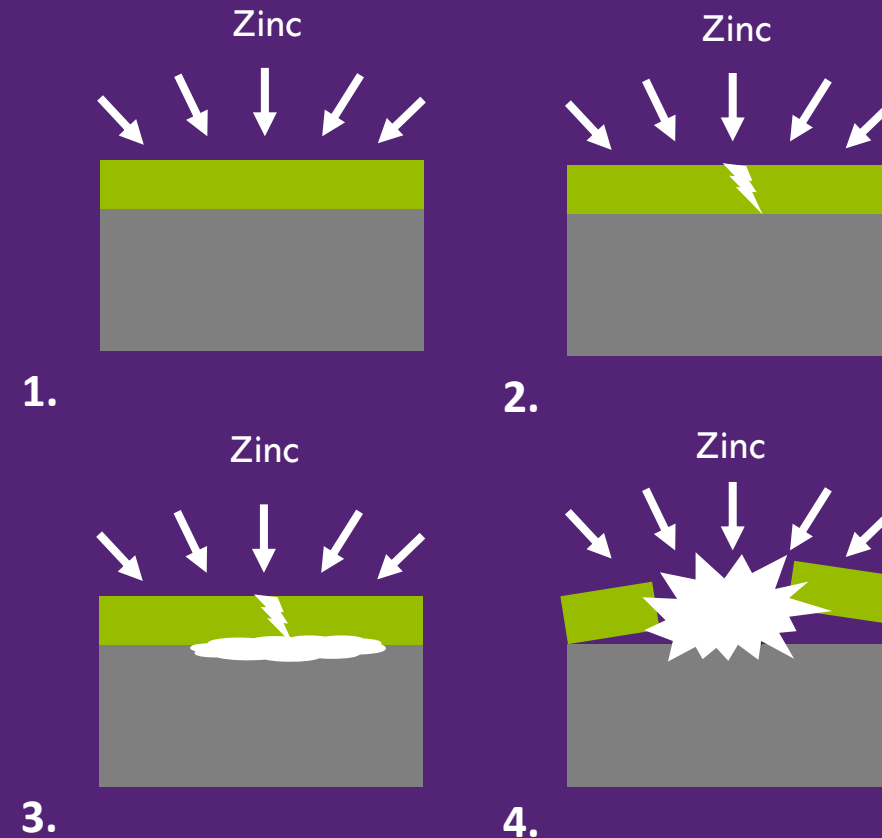
- SS 316L:  $20 \times 10^{-6} \text{ K}^{-1}$  [1]
- $\text{Al}_2\text{O}_3$ :  $8 \times 10^{-6} \text{ K}^{-1}$  [1]

1. Wetting of the sample with liquid zinc
2. Zinc penetration through cracks
3. Accumulation of reaction products
4. Coating break down
