Comparison of Squats and Studs from different traffic environments

Shaun Earl, Prof. Roger Lewis, Prof. Mark Rainforth: University of Sheffield

1. Squats and STUDs
2. The use of μ -CT scanning on rail defects
3. X-ray Micro-Computed Tomography (μ -CT) Scanning
4. Scan verification
5. Sample 1
6. Sample 2
7. Sample 3
8. Sample 4
9. Concluding remarks

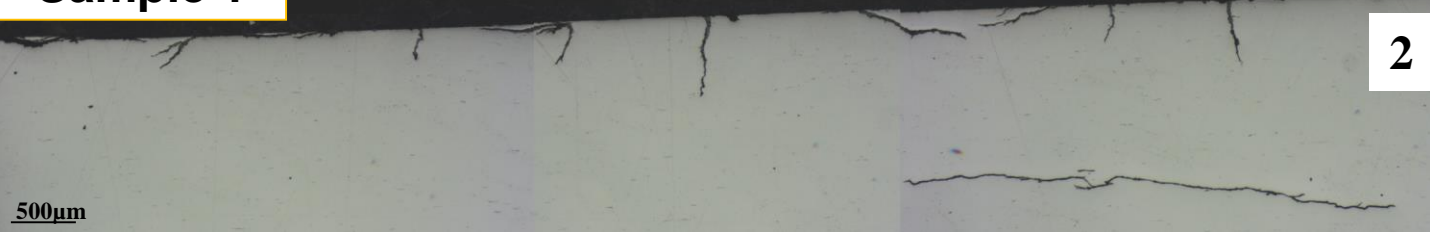
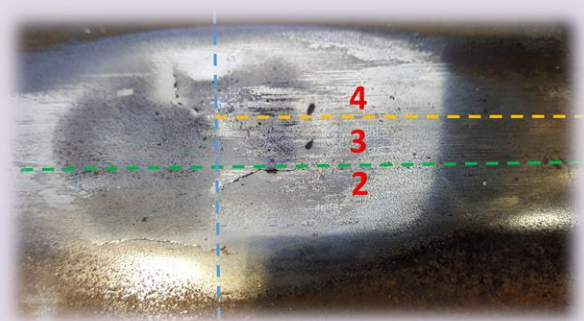
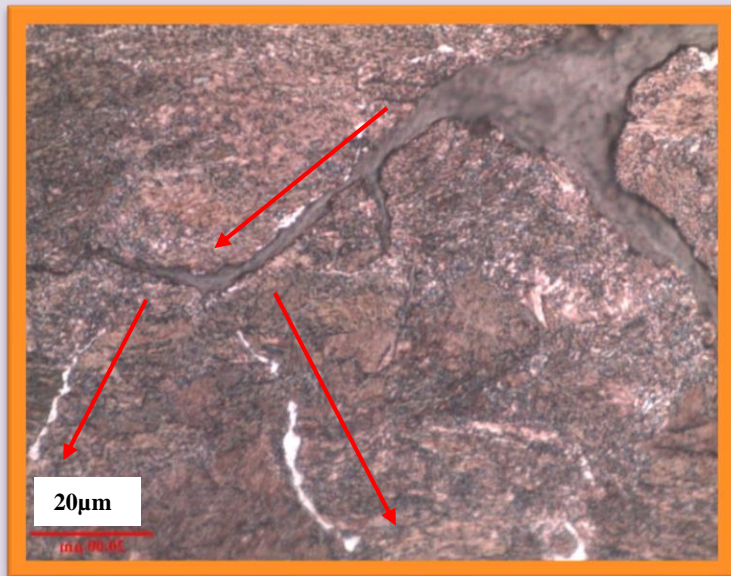
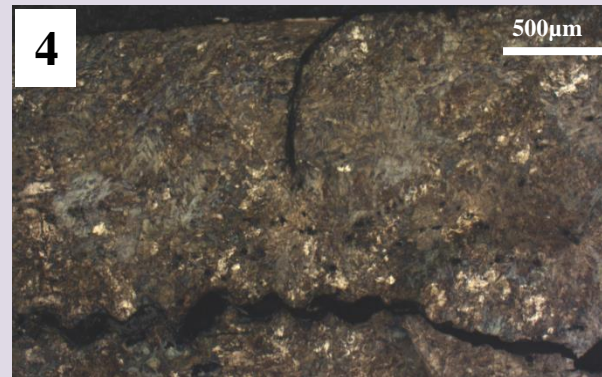
Sample 1

- From an incline just outside a station
- Multiple surface breaking cracks
- Typical crack structure that branches
- Initiated on the field corner

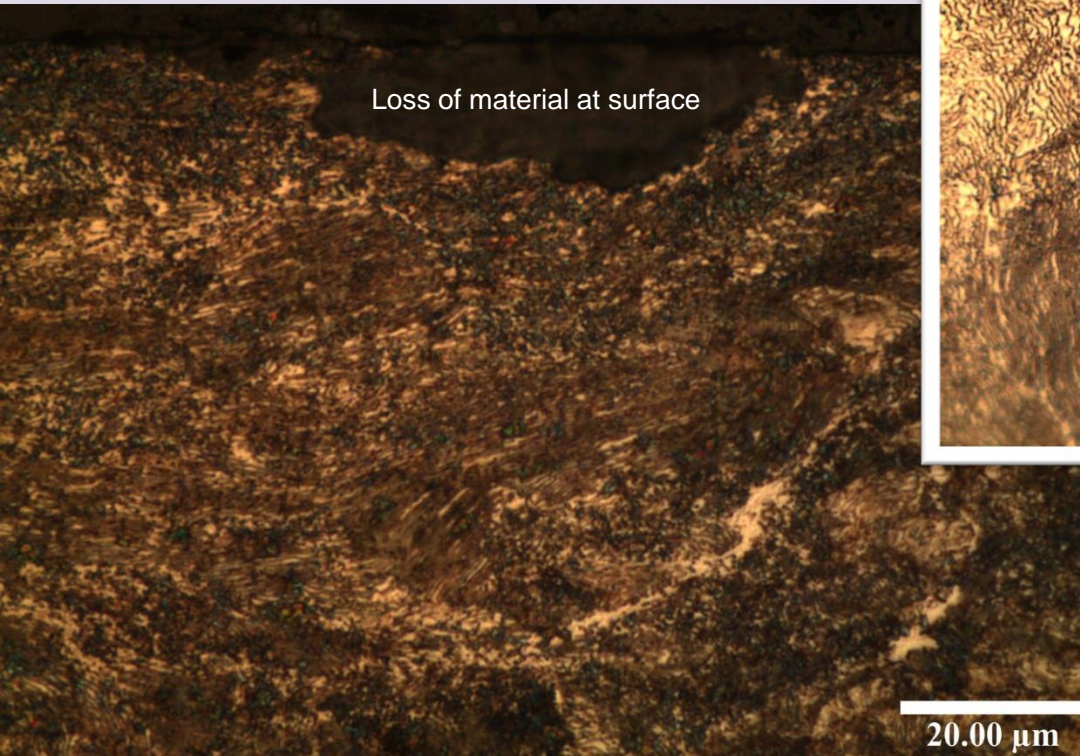
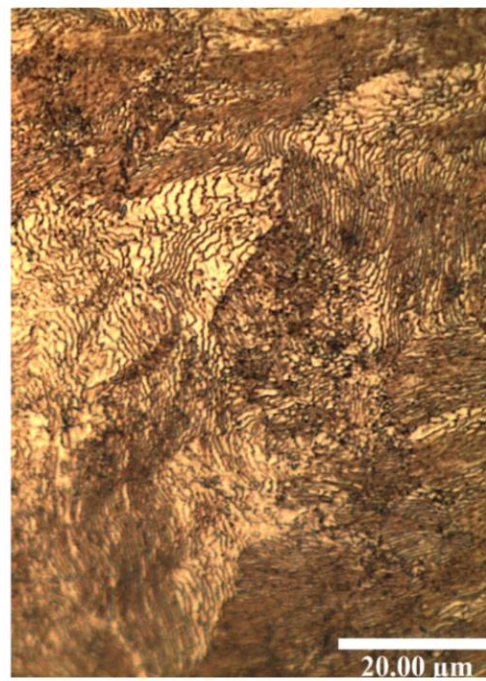
Sample 1

50 microns
between
images!

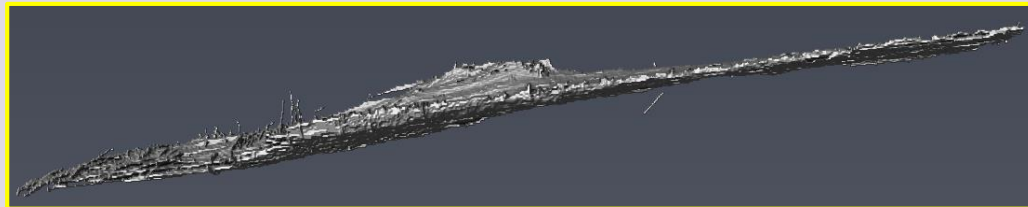
Automatic functions could not detect a large portion of the crack plane. Manual additions were made.

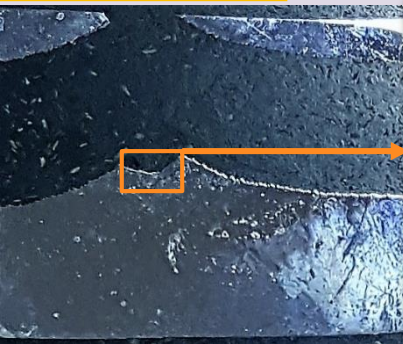
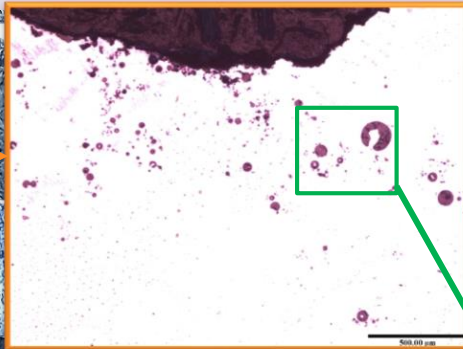
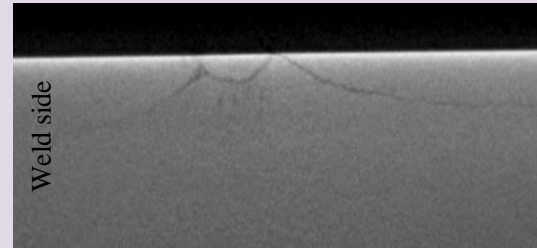
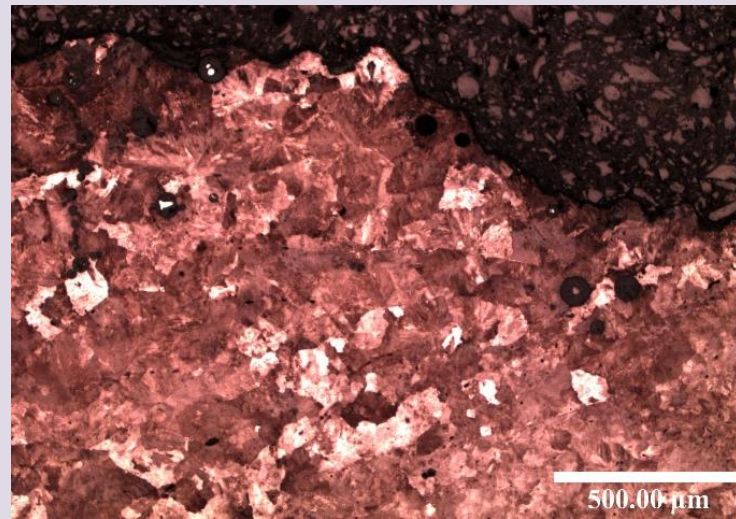
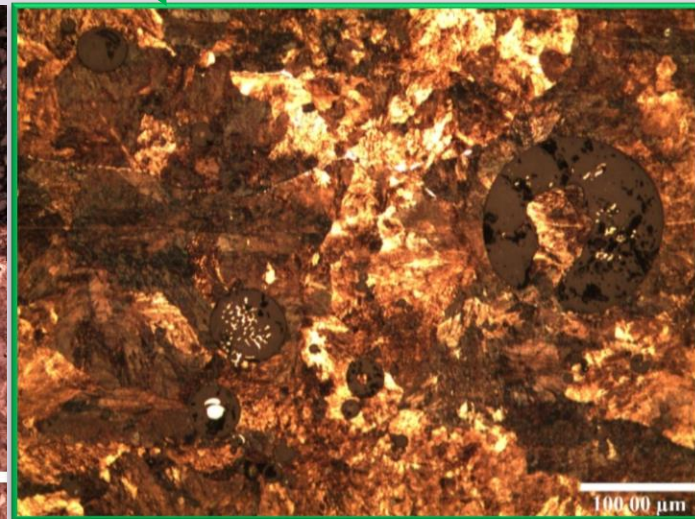
- Samples 1 and 2 initiated on the field corner
- Sample 2 has a crack that is believed to be developing transversely
- Sample 4 contains gas bubbles within the weld where initiation occurred
